To: Town of Amherst Historic Commission and Town CPA Committee  
From: Bruce Coldham FAIA  
Date: November 2019  
Subject: CPA FY-20; Grant to NACF— SGF Farmhouse window restoration;  
1089 North Pleasant Street, Amherst, MA  
First Progress Report

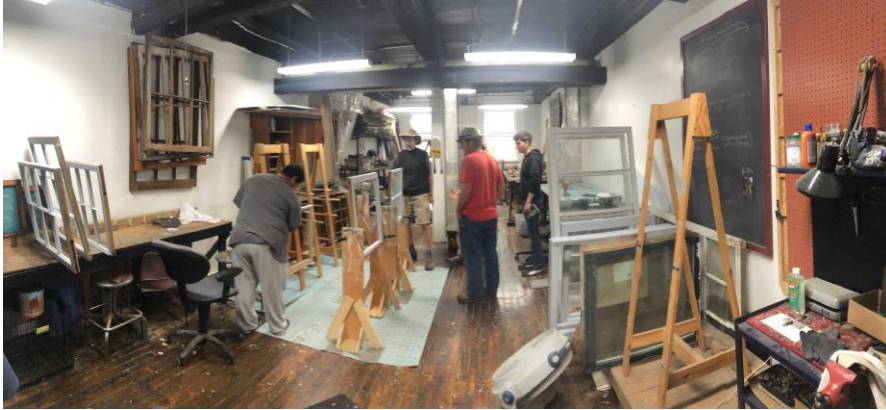
We visited the Old Window Workshop (OWW) and inspected progress with our sash restoration. It allowed the carpenters to see exactly what was being done and what a finished, restored sash would look like.

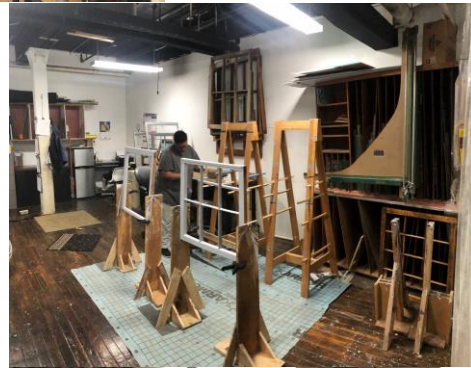
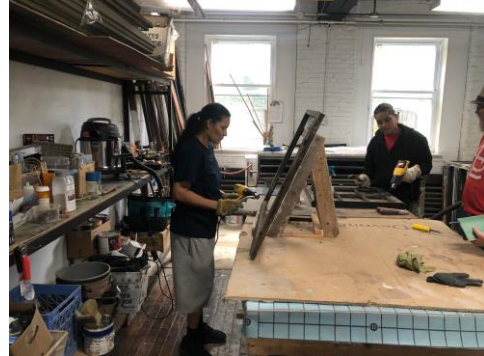
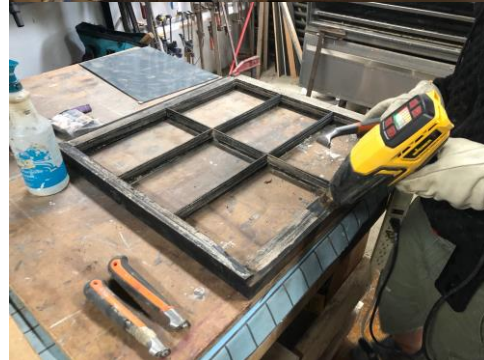
We also reviewed the work involved in cutting the routed kerfs to receive the air-sealing gaskets, and decided that this portion of the work was best done by our carpenters.

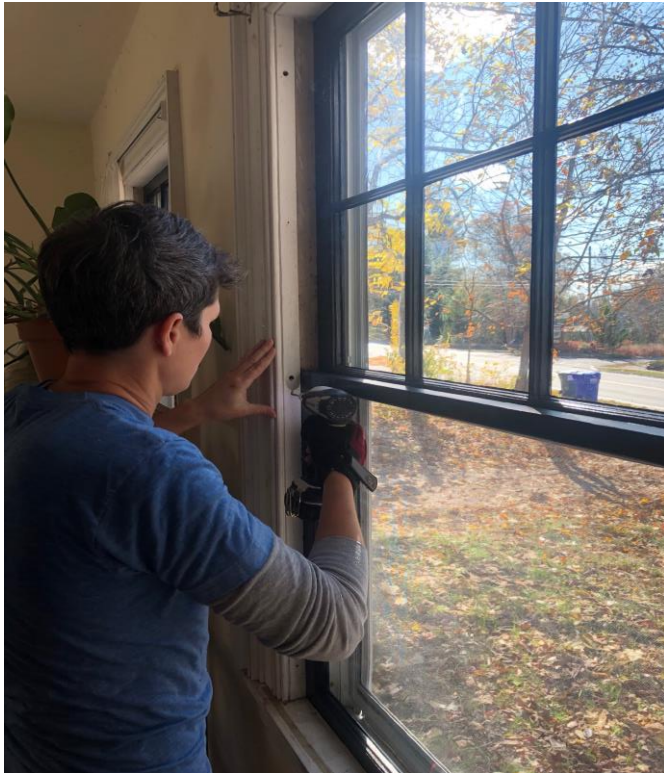
Fitting a newly restored lower sash; the top sash has been fixed permanently inoperable, and sealed tight.

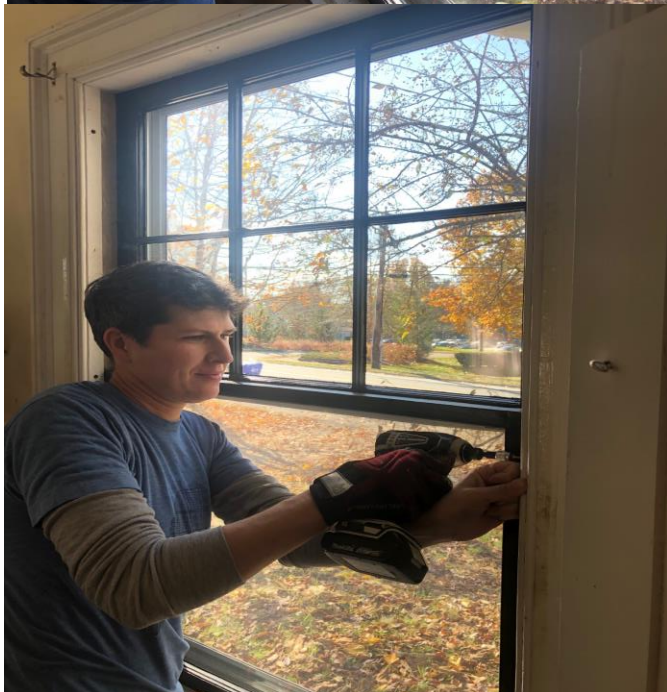
Fitting a newly restored lower sash
